Revision of an AAA Endograft Supported by Artis zeego and *syngo* DynaCT

Courtesy of Amit V. Patel, M.D.,
Morristown Memorial Hospital, Morristown, NJ, USA

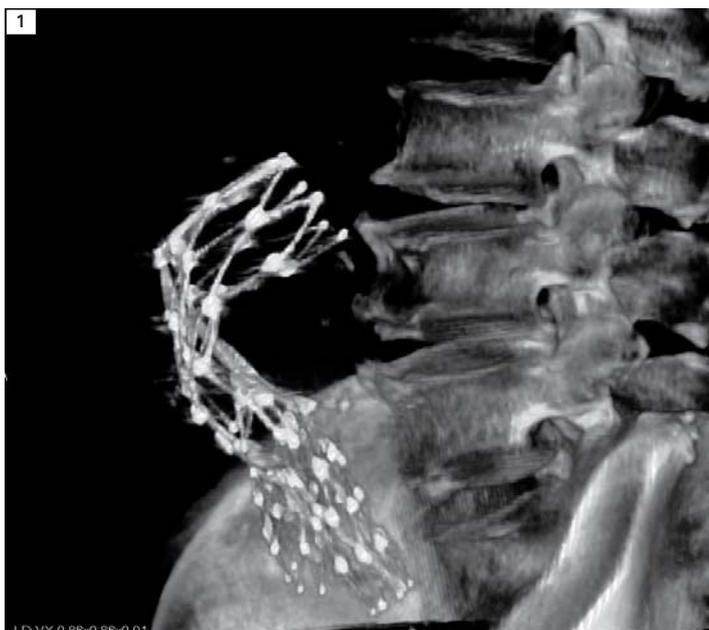
- 1** syngo DynaCT showing position of old stent.
- 2** 3D Angio clearly showing the endoleak.
- 3** Visualization of mass wire at the aortic bifurcation.
- 4** syngo DynaCT image of the repaired stent without endoleak.

Access to the arterial system was obtained from both femoral arteries. *syngo* DynaCT images were obtained which clarified the position and structural position of the old stent (Fig. 1). A 3D angio was also performed which shows the position of the migrated device and the endoleak (Fig. 2). Another endograft system, with supra-renal fixation, was advanced from the right, positioned, and then deployed in position. The contralateral gate to this device was obstructed by the prior device's stent structure, which had created a mass of wire at the aortic bifurcation (Fig. 3). Ultimately, a large balloon was used to deform the old stent, and then appropriate access to the new stent from the left was performed. The new stent system was completed and completion studies show an excellent result with exclusion of the aortic aneurysm. Another *syngo* DynaCT acquisition shows the relationship of the two devices, as well as the integrity of the repair, with no evidence of an endoleak (Fig. 4).
