# SPECT/CT delineation of patellar and femorotibial overload after knee arthroplasty

By Christian Waldherr, MD and Partha Ghosh, MD  
Data and images courtesy of Engereid Hospital, Bern, Switzerland

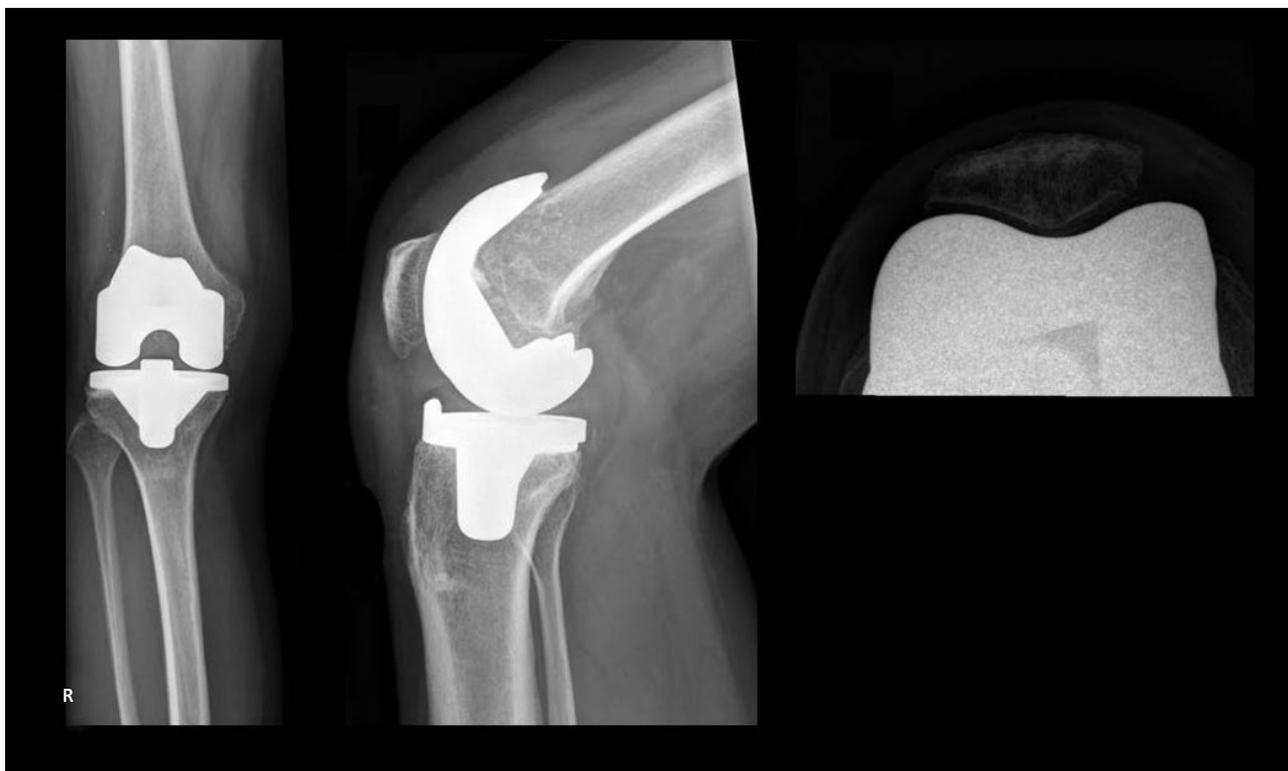
- 1** Anterior, lateral, and end-on radiographs of the right knee suggest correct axial and vertical positioning of the patella and absence of lysis among the components of TKA, which reflect absence of patellar misload and absence of radiographic signs of loosening or fracture. The periprosthetic femur shows slight radiolucency, which reflects erosion of the bone. The patella is undisplaced with normal concavity of the articular surfaces but shows significant radiolucency, which reflects periarticular bone loss. The radiograph suggest a slight varus mal-alignment when compared to the opposite knee (not shown).

The prior radiographic information was inconclusive (Figure 1) since there was no sign of loosening (lysis), periprosthetic fracture, or particle disease. In patients with painful joints after arthroplasty,

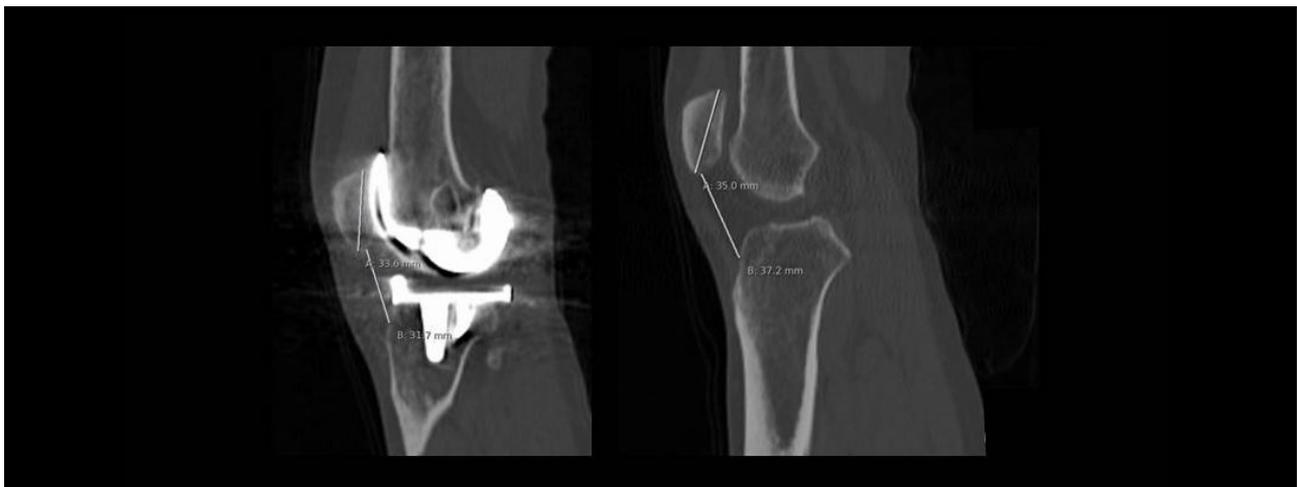
**8** Sagittal CT slices of right and left (normal) knee joints used for determination of IS ratio of both knee joints. Both knees show normal IS ratio of  $< 1$ . Normal IS ratio is 0.8 to 1.2.

hypermetabolism is lower than that of the patella and is likely not the principal cause of pain. The patellar hypermetabolism in absence of any patellar misalignment, malrotation, or displacement suggest patellar overload secondary to genu varum deformity. The normal IS ratio and TT-TG distance in the right knee also suggests stable patella with proper position of patellar articular surface in the trochlear groove of the femoral component of the TKA prosthesis. This rules out patellar malalignment or maltracking as a cause of the patellar hypermetabolism, thereby confirming patellar overload stress caused by varus deformity of right knee.
