SPECT/CT in evaluation of anterior knee pain following patellofemoral arthroplasty

By Christian Waldherr, MD, and Partha Ghosh, MD
Data and images courtesy of Engereid Hospital, Bern, Switzerland

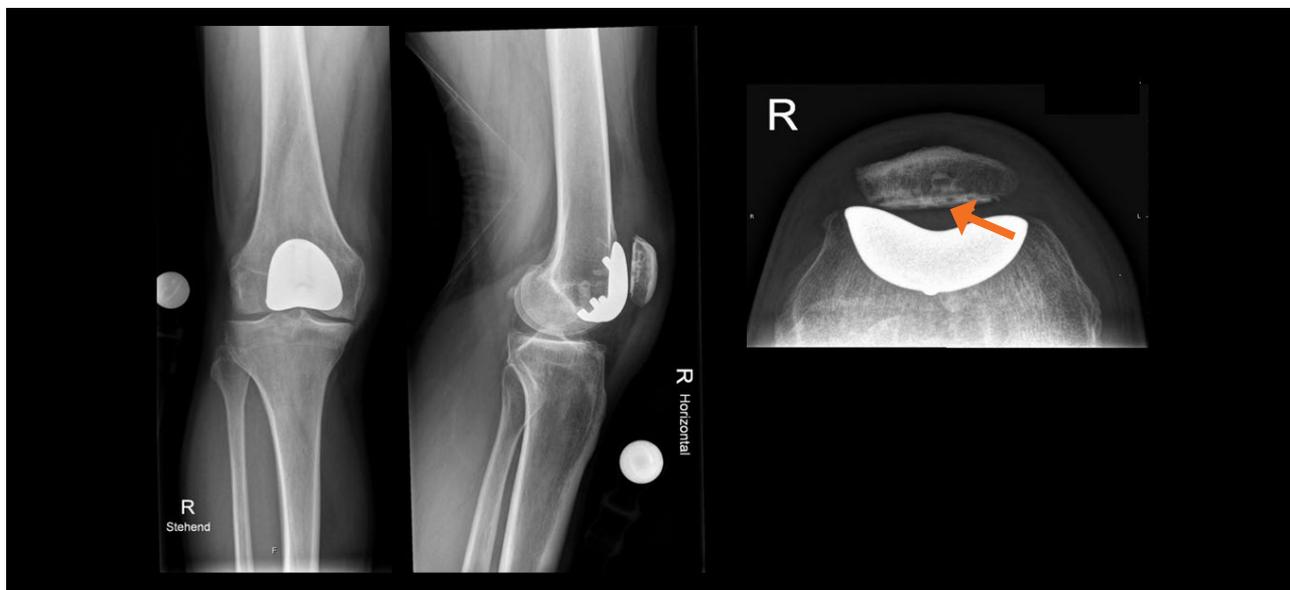
1 Anterior, lateral, and end on radiographs of the right knee joint show the patella-femoral arthroplasty prosthesis fixed on the trochlear groove, extending to the medial aspect of the upper part of both the medial and lateral femoral condyles, and articulating with the patella. There is no visible gap between the femoral condylar bone and prosthesis, which suggests an absence of loosening. The articulating surface of the patella is flat with bony sclerosis (arrow) rather than concave, which is probably secondary to patellar resurfacing at the time of arthroplasty. There is a significant gap between the prosthetic trochlear concavity and the patellar articular margin with larger gap medially suggesting a slight lateral shift of the patella with pathological tilt.

Radiography in this patient shows an abnormal gap between the flat patellar-articular surface with sclerosis following resurfacing and the anterior margin of the patella-femoral arthroplasty prosthesis, which is attached to the trochlear groove with suggestion of exaggerated tilt of the right patella. The mild hyperemia of the right patella seen in the bloodpool images correlates with the lateral patellar hypermetabolism seen on the planar whole-body image, which reflects patellar overload secondary to patella-femoral arthroplasty (Figures 1 to 3). Although the mechanical axis of the right femur and tibia are aligned and no valgus or varus deformity is visualized in the right knee, the minor hypermetabolism in the medial femoro-tibial compartment probably reflects slight medial femoro-tibial overload. In this context, bone SPECT/CT is key to the accurate identification of focal stress overload and evaluation of patellar, articular and prosthetic instability, displacement, loosening, periprosthetic fracture, and mal-alignment.

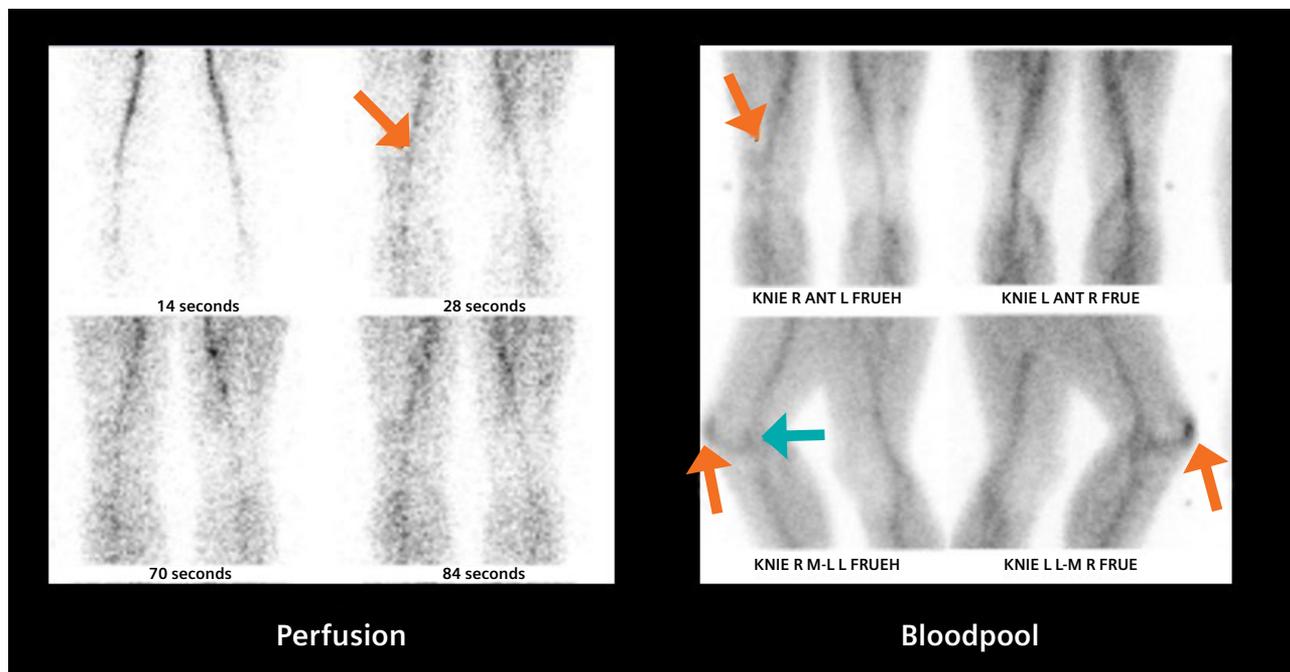
2 Dynamic planar perfusion and static bloodpool images show mild hyperperfusion and slightly increased bloodpool in the right patellar region (orange arrows) reflecting bone hypervascularization reactive to overload stress. A slight increase in bloodpool activity in the articular region (blue arrow) reflects minor synovitis.

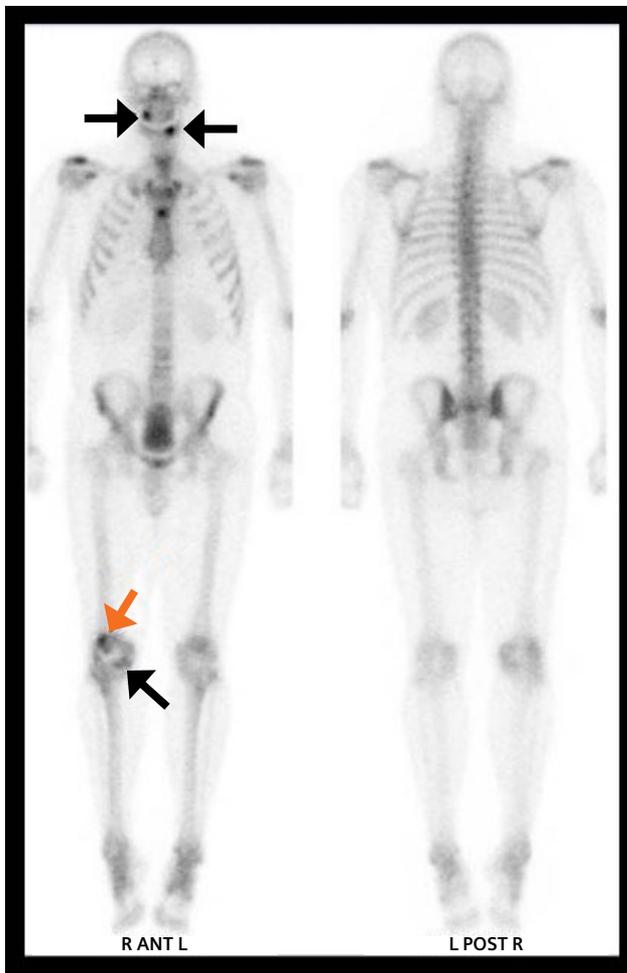
3 Planar anterior and posterior whole-body images show increased uptake in the right patella (orange arrow) along with mild hypermetabolism in the medial condyle of tibia. The mechanical axis of the femur aligns to the tibial shaft axis without significant varus or valgus abnormality, as seen in the anterior whole-body images. The highest intensity of uptake is in the lateral part of the right patella, which appears to be the key focus of bone stress, with the medial tibial condyle showing only minor hypermetabolism that is unlikely to be related to major bone stress in the context of normal femoral and tibial mechanical axes.

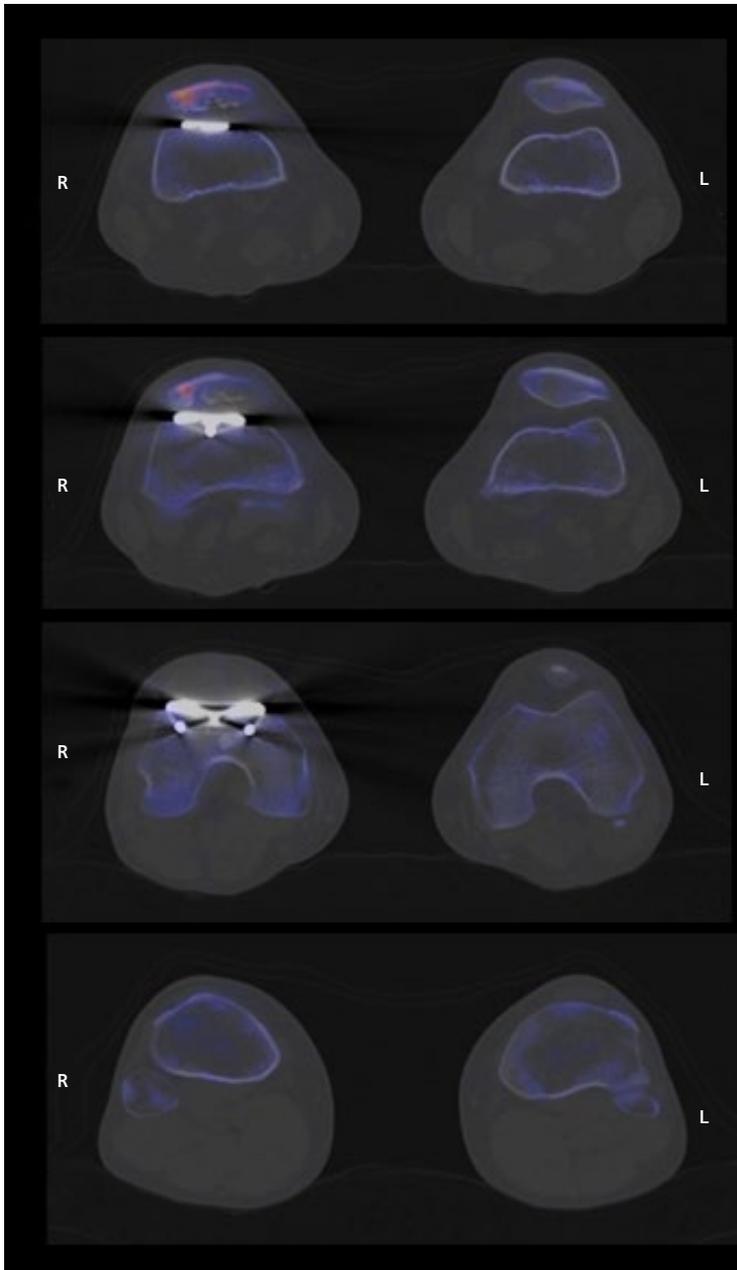
- 4** Axial-fused SPECT/CT slices through both knee joints show focal hypermetabolism within the patella predominantly in the lateral aspect. Patellofemoral arthroplasty prosthesis is properly fixed to the trochlear groove without any periprosthetic lysis. There is also no gap between prosthetic margin and adjacent femoral bone suggesting an absence of loosening or displacement of prosthesis. Additionally, there is no focal abnormal uptake in the periprosthetic femoral bone, which rules out prosthetic loosening, periprosthetic fracture, periprosthetic bone stress related to faulty prosthetic placement, and prosthetic instability.

As evident from the SPECT/CT images (Figures 4 to 8), the primary site of stress overload is localized to the lateral part of the right patella but without any evidence of patellar fracture, prosthetic loosening, or periprosthetic focal bony stress or fracture. Predominant lateral patellar stress in absence of any other evidence of significant femoro-tibial focal hypermetabolism suggests presence of patellar overload with a lateral patellar tilt, which may reflect incorrect positioning of the prosthesis with the patellar-articular surface.

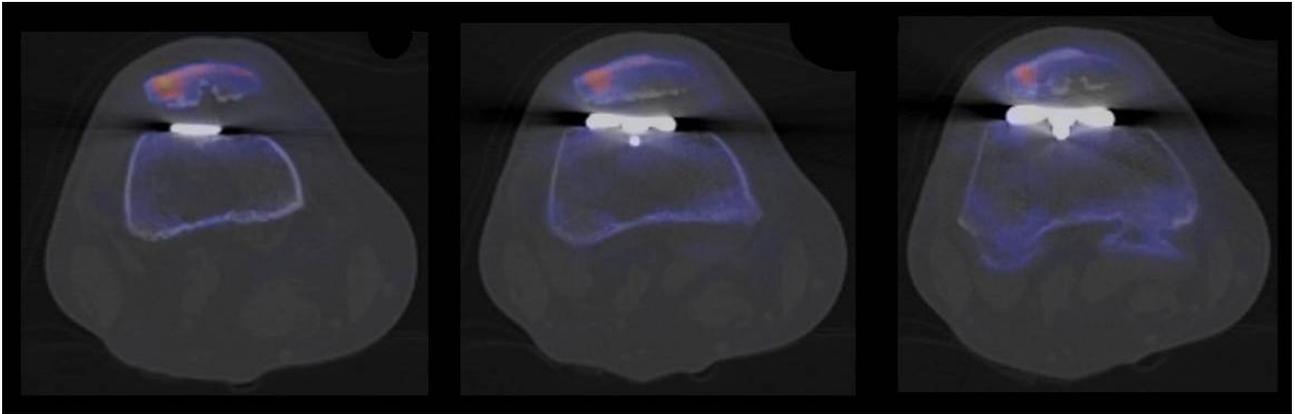
- 5** Enlarged axial-fused SPECT/CT slices through the knee joint at multiple levels through the patella show focal hypermetabolism in the lateral part of patella predominantly involving the anterior and middle part of the entire patellar thickness. The patellar-articular surface appears irregular with mild sclerosis reflecting patellar resurfacing but without significant articular surface hypermetabolism. This suggests that the hypermetabolism is predominantly due to patellar overload stress mostly in the lateral aspect without significant friction at the articular surface.

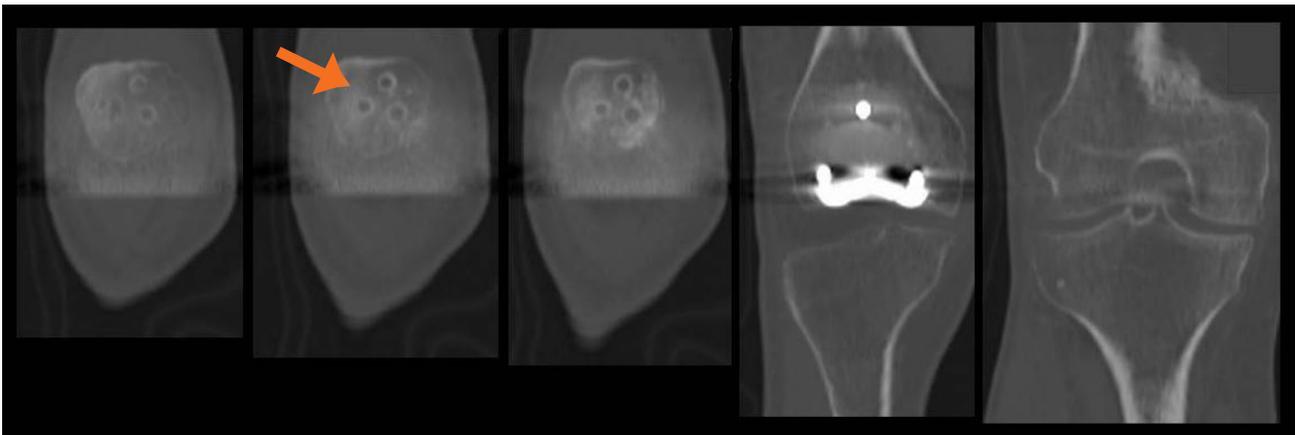
- 6** Coronal CT slices from anterior to posterior aspect of the knee joint shows mild bony sclerosis in the lateral part of the patella (orange arrow). The CT delineates drill holes in the patellar cortex related to previous resurfacing of the patellar articular surface and there is no indication of patellar fracture. Additionally, prosthetic margins are well approximated to the adjacent femoral bone. Medial and lateral femoral condyles and both tibial condyle and tibial tubercles do not show significant irregularity of articular surface. The joint spaces appear normal.

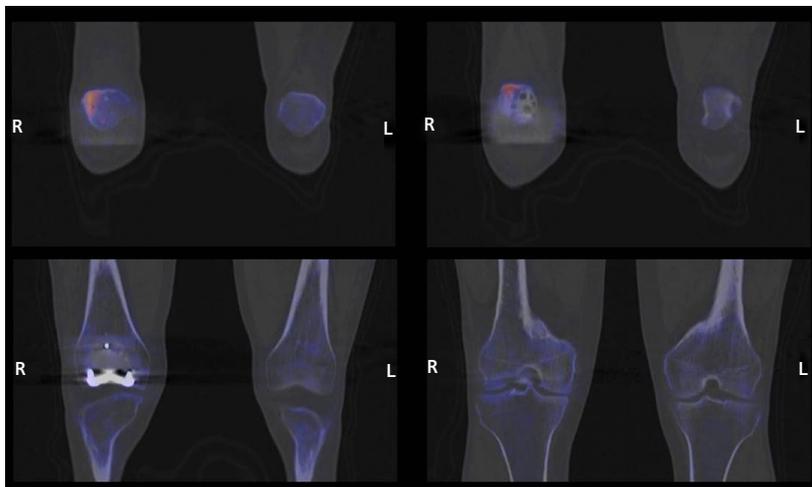
- 7** Coronal-fused SPECT/CT slices through the knee joint from anterior to posterior show focal hypermetabolism in the lateral aspect of right patella corresponding to CT findings of mild patellar sclerosis. There is no hypermetabolism seen in the periprosthetic bone and tibio-femoral condylar and joint space and prosthetic loosening or displacement is not visualized.

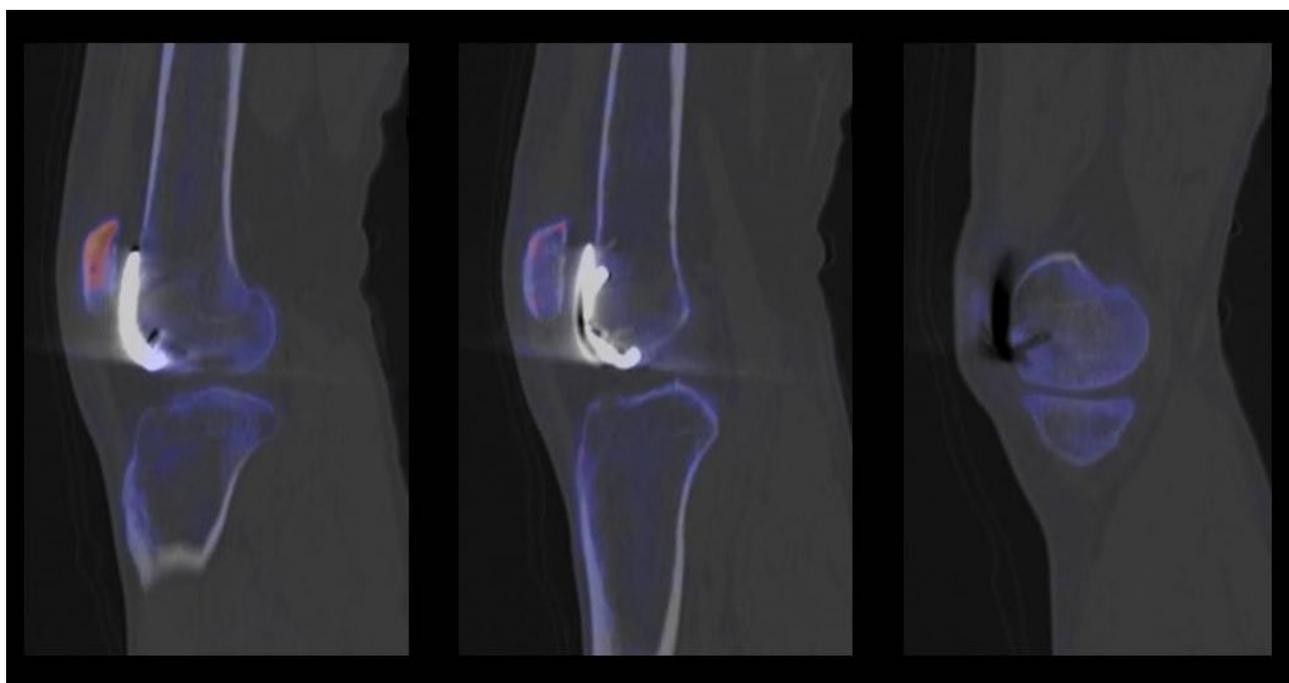
- 8** Sagittal-fused SPECT/CT slices through the right knee joint from lateral to medial show hypermetabolism in the patella in the upper lateral part. Sclerosis in the patellar articular surface is visualized. Patello-femoral arthroplasty prosthesis attached to the anterior aspect of lower femur in the trochlear groove and inter-condylar space show no evidence of displacement or loosening. No other periprosthetic, condylar, or articular hypermetabolism is visualized. Femoral and tibial condylar margins and joint spaces are unremarkable.

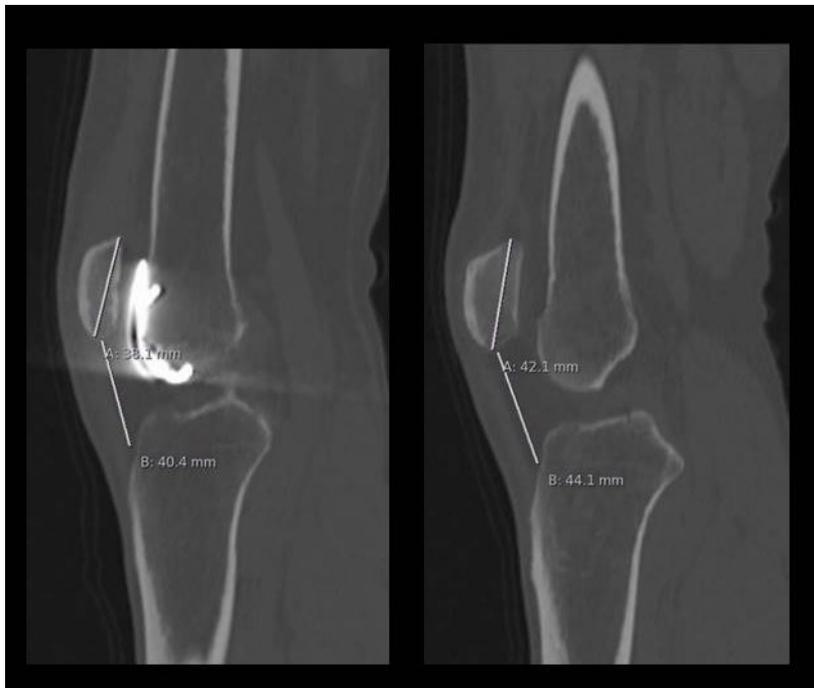
9 Sagittal slices through CT of right and left (normal) knee joints for determination of Insall-Salvati (IS) ratio of both knee joints (ratio of patellar tendon length or length of the posterior surface of the tendon from the lower pole of the patella to its insertion on the tibia (TL) to the patellar length or greatest pole-to-pole length of the patella (PL)). Both knees show a normal IS ratio of 1.05.

The indices of knee joint stability such as the IS ratio and TT-TG distance (Figures 9 and 11) as calculated from the CT data are normal for the right knee, thereby confirming absence of any prosthetic displacement, mal-alignment, or joint instability. The larger-than-normal right patellar tilt (Figure 10) measured on the axial CT images clearly shows the lateral tilt of the right patella, which may have an impact on the lateral patellar overload.

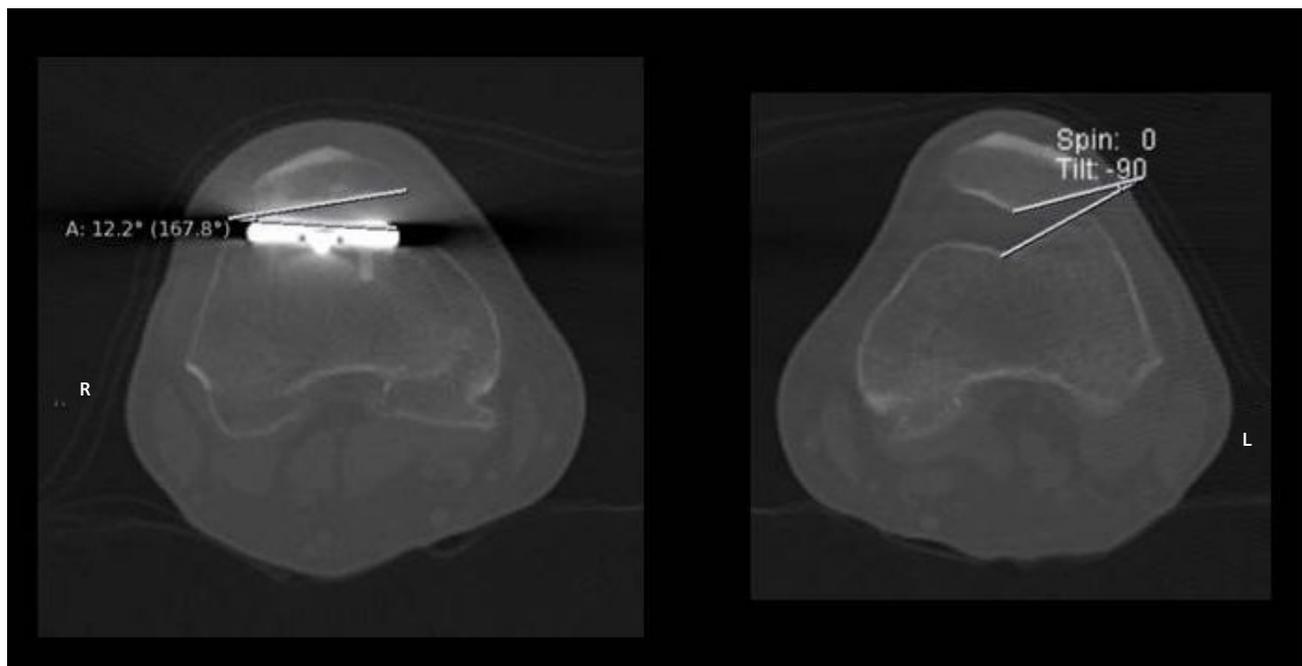
10 Axial CT slices through the right and left knee joints showing pathological patellar tilt on the right side (prosthesis). The patellar tilt angle is defined as the angle formed by a line drawn parallel to the lateral patellar facet and the posterior condylar line. In presence of prosthesis in the right knee, the angle between a line drawn along with anterior edge of the prosthesis attached to the right femoral trochlear groove and the flattened articular surface of the right patella is the closest approximation of the patellar tilt angle. In this patient the right patellar tilt angle (12%), is abnormally high and suggests significant medial patellar shift, which may explain the overload stress on the right side of the patella. The left knee joint also shows a higher than normal patellar tilt angle.

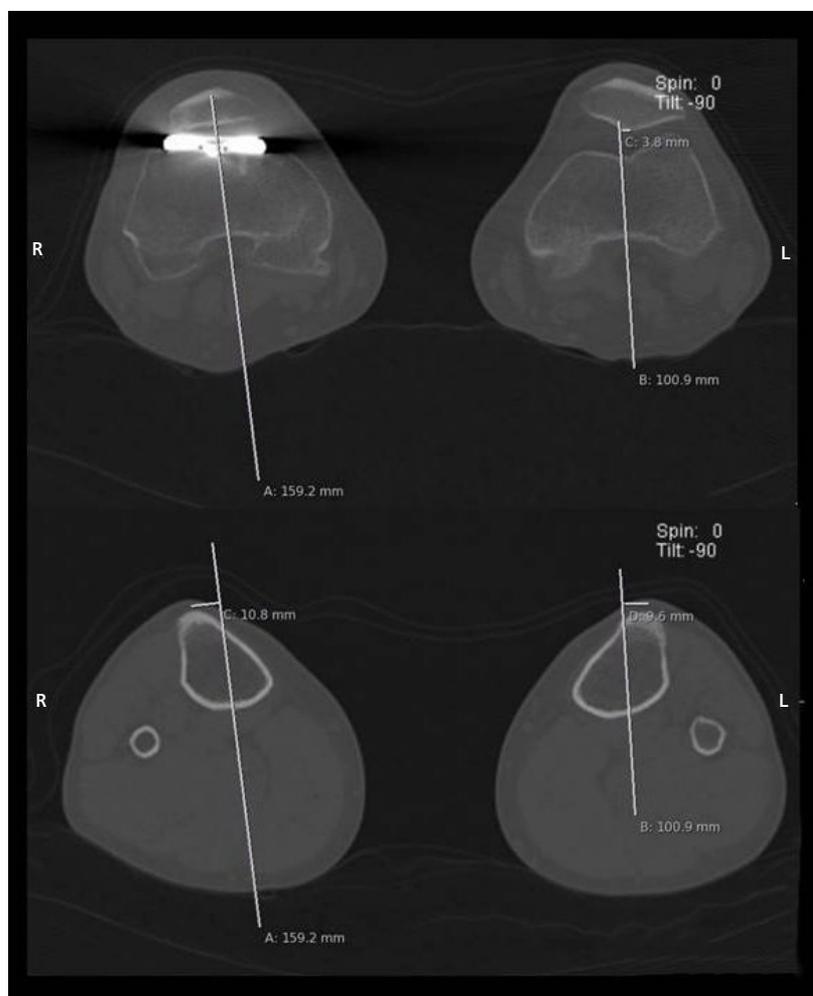
- 11** Axial CT slices through both knee joints at the level of the trochlear groove of the femur and the tibial tuberosity with lines drawn through the tibial tuberosity (TT) and trochlear groove (TG) perpendicular to and bisecting the line joining posterior edges of both femoral condyles (TT and TG lines). The distance between these lines (TT-TG distance) for both knees is about 1 cm, which is within normal limits and suggests absence of any knee joint instability.
